The Vanishing Heritage of Sheikhpura Fort: Causes, Condition, and Conservation

Rafia Gulzar¹, Saad Mujahid², & Kabeer Ud Din Naseer³

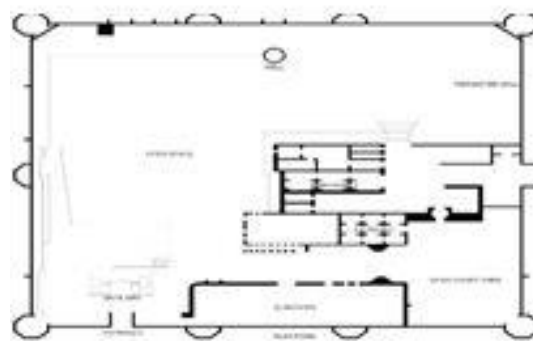
Figure 3 Architecture plan of fort
(Source: Author)

The fort has a rectangular plan with dimensions of approximately 270 by 300 meters. The fort is surrounded by a high wall with circular bastions at the corners, and there are two gateways on the east and west sides. The fort's interior is divided into several courtyards, including the royal palace, mosque, and barracks for soldiers. The architecture features intricate decorative motifs and Islamic geometric patterns. The Mughal architectural elements of Sheikhpura Fort, such as its high fortification walls and bastions, demonstrate the strategic and aesthetic priorities of Mughal military architecture (Sultana, 1989).

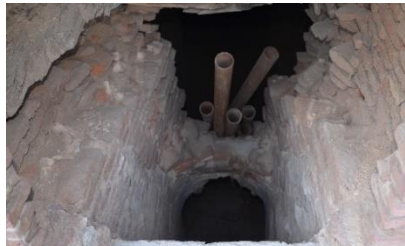
Figure 5 Basement chamber through courtyard (Source:Author)

It is designed with an elevated terrace as the internal level of terracing. The terrace is about 10m higher than the ground outside and is filled with solid earth up to parapet level. Towards the northeastern part, the terrace covers a series of double-storied basement chambers built beneath the eastern side of the northern portion of the rampart. The first tier of the basement chambers is half underground with three arched openings on the northern side. The underground floor covers a spacious area of nearly 60m long and 12m deep, divided into cellars that probably served as guard quarters during the Mughal times and storage in later periods. The upper story of the basement chambers likely served as dormitories for the emperors and princes during their halts at Jahangirpura. The decorative features and possible wall paintings have suffered irreparable damage from misuse under Sikh and British occupations.

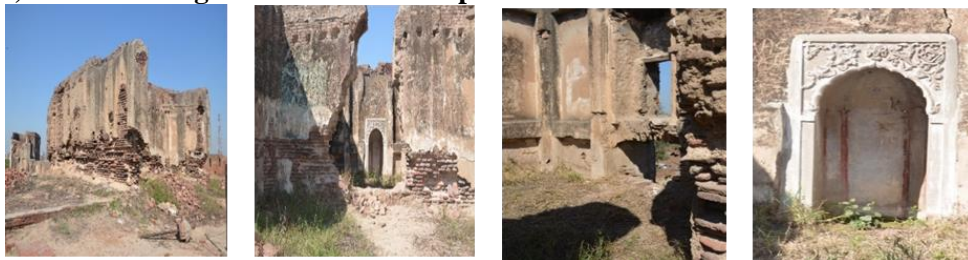
Figure 12 South side of Haveli (Source: Author)

Figure 11 North side arcade (Source: Author)

Figure 10 Palace courtyard (Source: Author)

Figure 9 Fallen part of the haveli (Source: Author)

The four-storied havelis of the transitional group are located to the west of the open courtyard and form an L-shaped block. Most of the buildings in the leg part of the complex collapsed in an earthquake and were cleared away subsequently. The zanankhana (women's quarters) occupies the leg part of the block and is segregated from the divan Khana (men's quarters) with separate entrances. This haveli of the zanankhana standing at the northern end of the block has its foundation probably resting on Earth fillings of uneven compactness or on one of the spanning arches of the basement chambers situated below. The foundation suffered damage under the load in the severe earthquake that took place in the latter half of the nineteenth century.

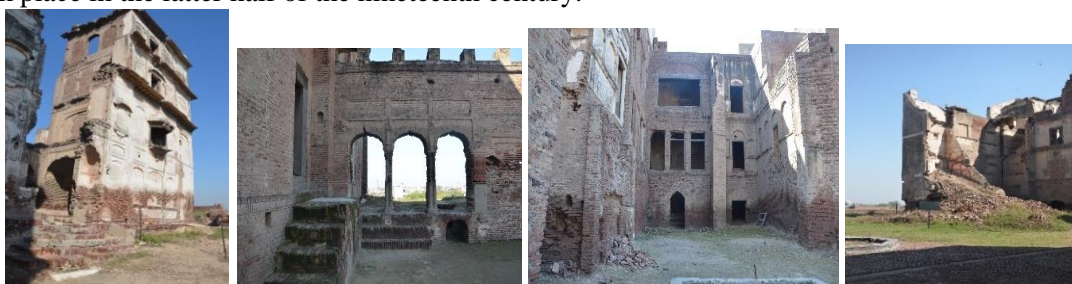
Figure 13 Fallen mosque on the rear left of the fort (Source: Author)

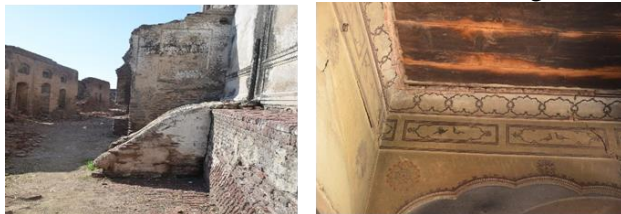
The annual rainfall of this part is 20 inches. Rain damages buildings at high rates. The exposed fortification walls have scaling due to this. The water floods on the roofs due to no proper drainage and excavation of the water deteriorates the building.

The repairing is not done on time by the authorities. Timely removal of elements spoiling the buildings is not done for example removal of plants and repairs of water spouts. Blocked canals have caused deterioration in the materials, flooding in walls has caused substantial setbacks to the building.

Figure 17 Decaying in building sue to long flooding of water (Source:Author)

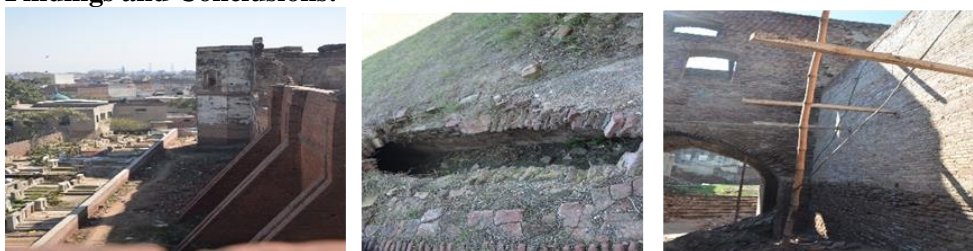
Figure 18 First phase of project left incomplete (Source:Author)

Upon visiting the Sheikhpura fort it was observed that so far, the conservation process of fortification wall is carried out. Buttresses have been added to stop the fall of the walls. Small minor canals have been digging out to give the rainwater a path away from the buildings and preventing the stagnant water collection at one distinct place. Frame structures have been added to several walls inside the fort. All other components of the project have yet to be processed.
